Report for airtest at 169 Pixmore Way, Letchworth

Compiled by Gervase Mangwana of Waxwing Energy on 24/2/2025

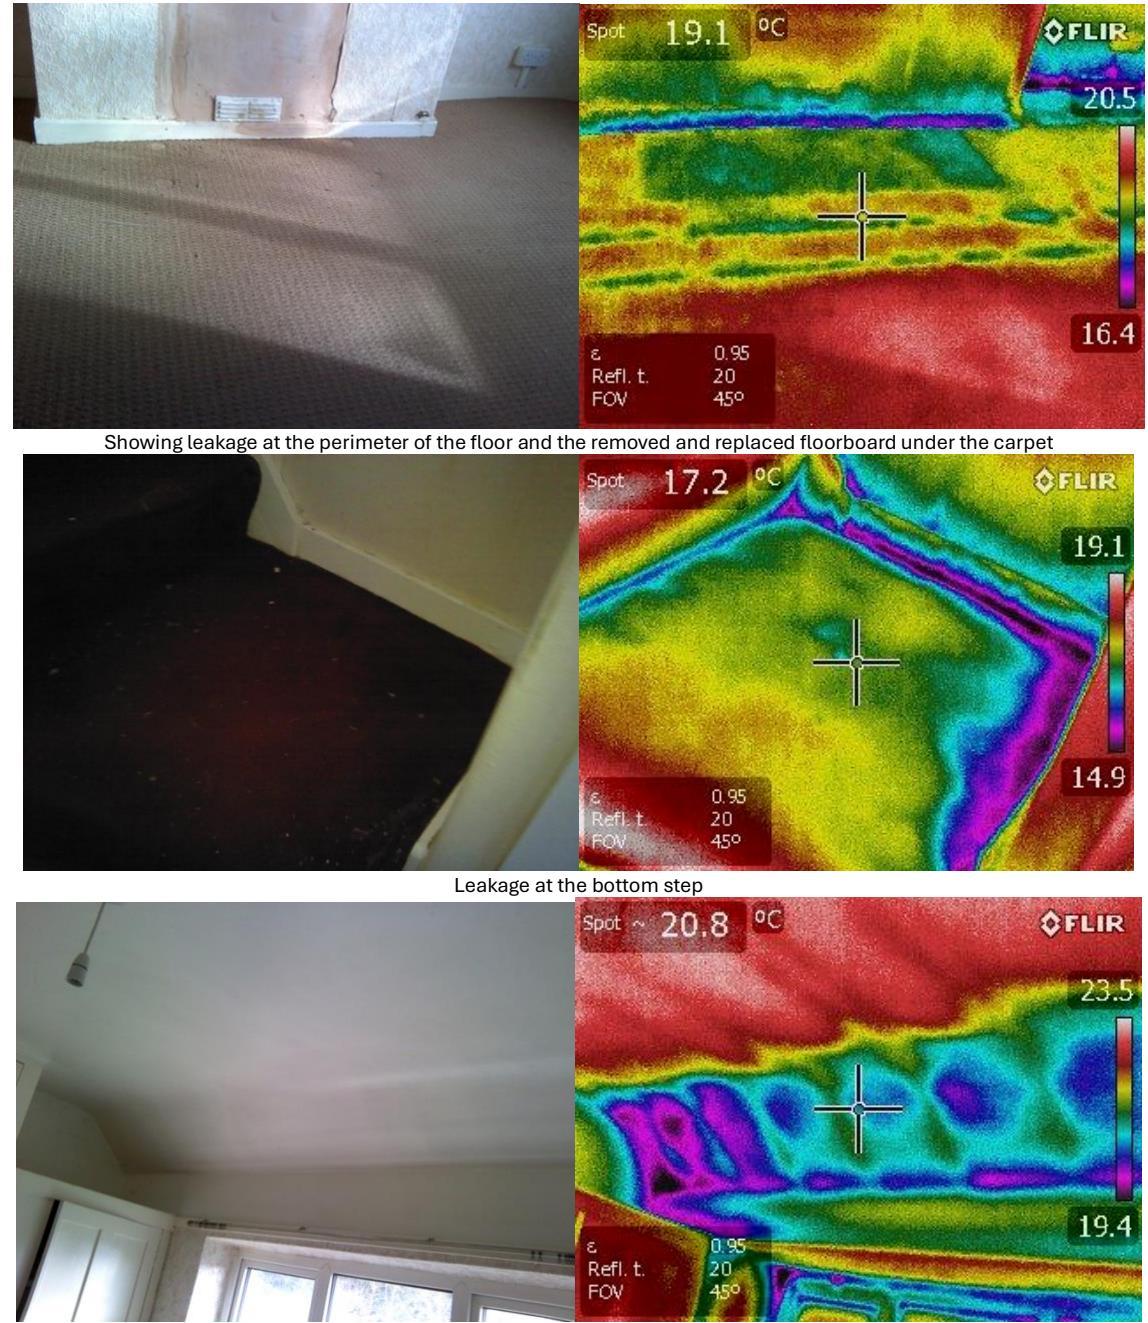
Uninsulated sloping ceiling

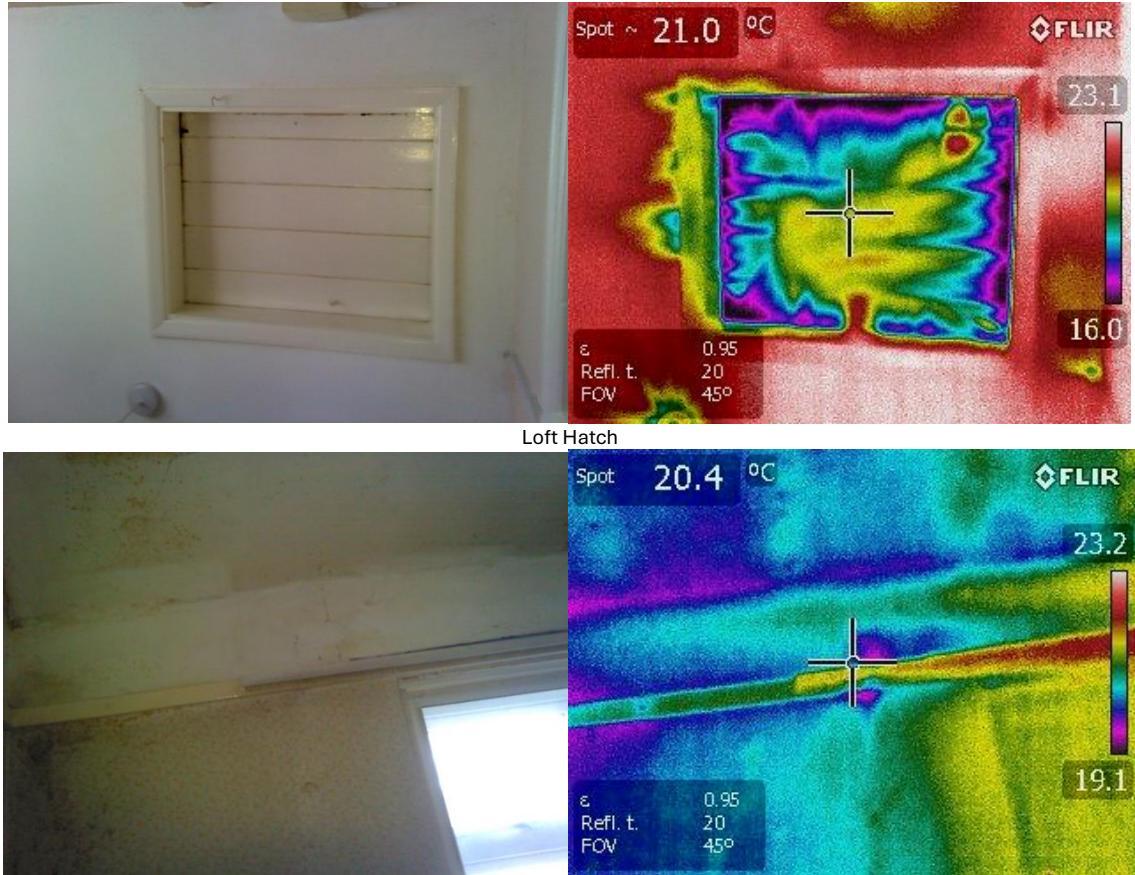
Leakage from behind picture rail.

In my there are good options for significantly improving the airtightness of this property. Were the ground floor to be sealed, new well fitted windows installed and ceiling penetrations including loft hatch addressed I believe this property could achieve an AP50 of **3m3/m2.h** or less. In order to get to better levels than this the more tricky area in the intermediate floor void will have to be treated. Its also worth noting that even at its current level a whole house continuous ventilation system should be implemented.
